RE: Ecological Characterization Study (ECS) Report for the Eldon James Corporation Project Area

FIGURE 1
Habitat Mapping for the Eldon James Corporation Project Area

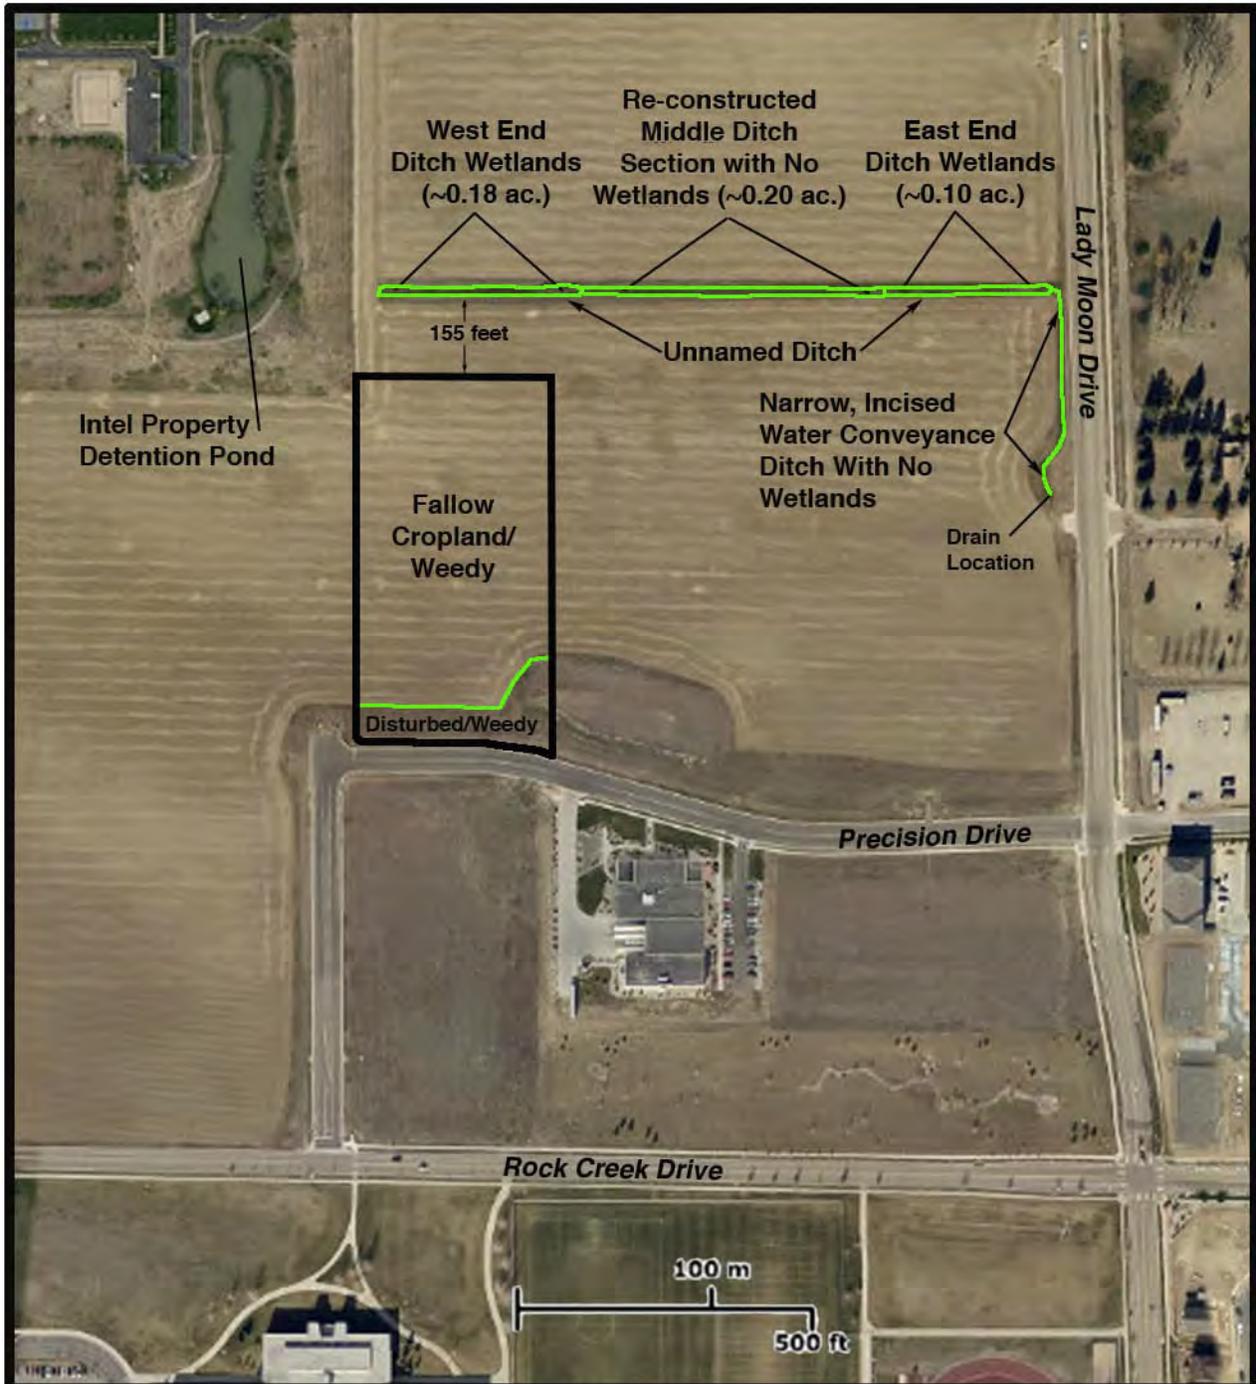
This letter report is submitted to satisfy the requirements of Section 3.4.1 of the Land Use Code of the City of Fort Collins regarding the submittal of an ECS Memo for the Eldon James Corporation project area (project area) in Fort Collins, Colorado. The report was prepared in accordance with Section 3.4.1 of the Land Use Code of the City of Fort Collins regarding the preparation of an ECS Report. The proposed development would be a 90,000 square-foot office and manufacturing facility. The project area is located near the northwest corner of the Lady Moon Drive/Precision Drive intersection in the southeast 1/4 of the northwest 1/4 of Section 4 (T. 6 N., Range 68 W.). The project area location is depicted on Figure 1. Existing commercial development and undeveloped land (fallow cropland) currently surround the project site (see Figure 1).

It is estimated that the unnamed ditch to the north of the project area formerly supported approximately 0.48 acre of wetlands, and currently about 0.28 acre of wetlands. Buffer requirements stipulated for less than 0.3 acre and greater than 0.3 acre are 50 feet and 100 feet, respectively. The Eldon James Corporation project area is 155 feet south of the south top of bank of the unnamed ditch (see Figure 1) so any development within the project area would be in compliance with either buffer zone requirement.

One mitigation recommendation is based on Article 3.2.4(D)(6) in the City of Fort Collins Land Use Code that requires protection of natural areas and natural features from light spillage from off site sources. Therefore, intensity of street or building lighting should be shielded or directed to minimize the intrusion of artificial nighttime light into the buffer zone for the unnamed drainage ditch.

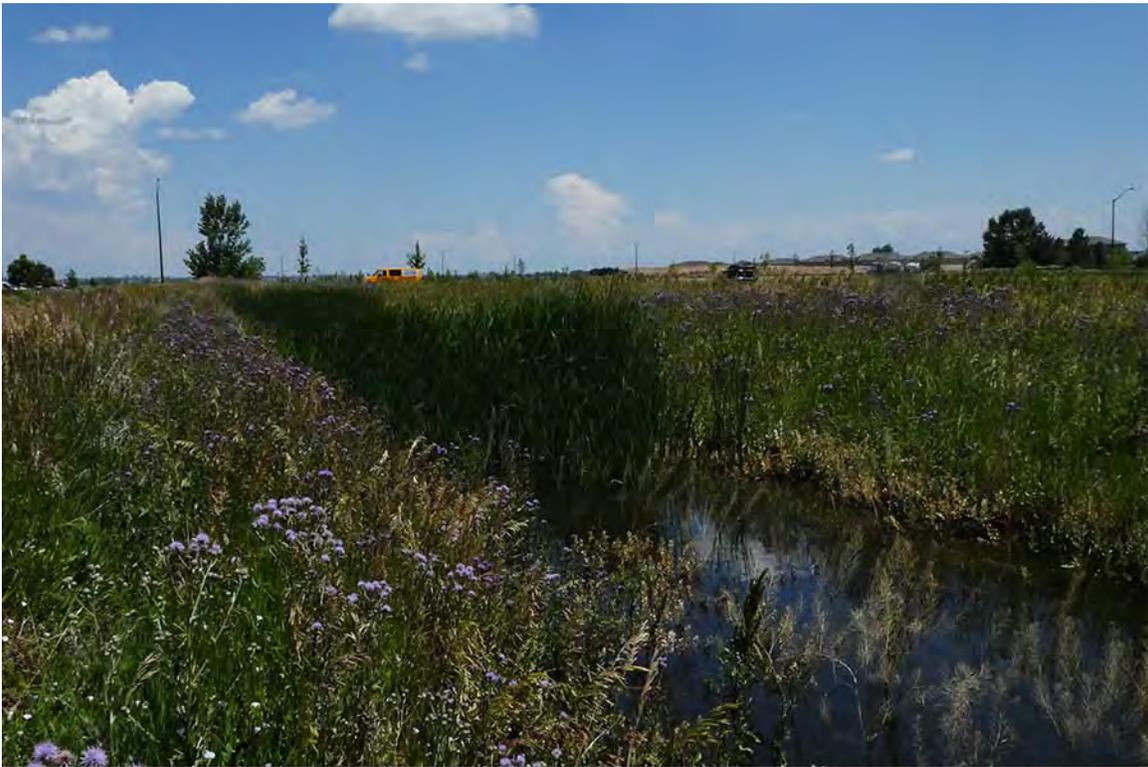
Characteristic wetland plants supported in the unnamed ditch wetlands are: narrowleaf cattail (*Typha angustifolia*), reed canarygrass (*Phalaris arundinacea*), Emory sedge (*Carex emoryii*), mountain rush (*Juncus arcticus*), showy milkweed (*Asclepias speciosa*), and narrowleaf (coyote) willow. At the time of the survey, current road building activities had constructed a filled road crossing and approximately 508 feet of newly constructed ditch channel scraped bare of wetlands. Current grading activities have also cleared areas of vegetation immediately adjacent to the wetland ditch channel. The perimeter of currently undisturbed ditch wetlands and the newly constructed ditch channel were circumscribed with a handheld GPS unit (accuracy \pm 6-12 feet) to determine the approximate size of remaining wetlands and the wetland area lost to recent grading and road fill activities. Total ditch length was determined to be 1,154 feet and the bank to bank width containing wetlands ranged from 22 feet at the west end to 15 feet at the east end. Estimated wetland size for the undisturbed west and east ends of the ditch was determined to be approximately 0.18 acre and 0.10 acre, respectively. It was also estimated that approximately 0.20 acre of wetlands was lost in the central portion of the ditch, which had been recently re-constructed (see Figure 1). Representative views of the vegetated wetland and recently re-constructed portions of the ditch are provided by attached Photos 1 through 4.

Photo 1. View of Undisturbed Wetlands and Open Water in the Eastern Portion of Unnamed Ditch. (View is from west end of east segment looking east. Dominant wetland vegetation in this view is narrowleaf cattail.)

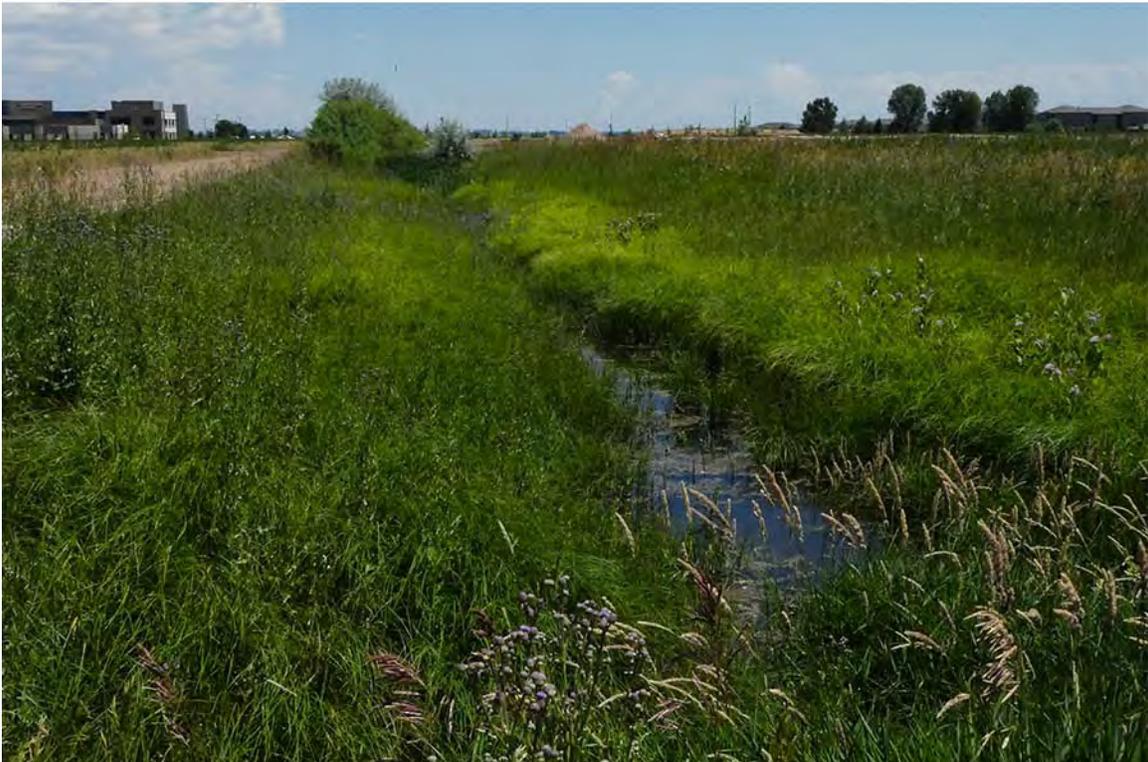
Photo 2. View of Undisturbed Wetlands and Open Water in the Western Portion of the Unnamed Ditch. (View is from west end of west segment looking east. Dominant wetland vegetation in this segment is reed canarygrass, Emory sedge, and mountain rush.)

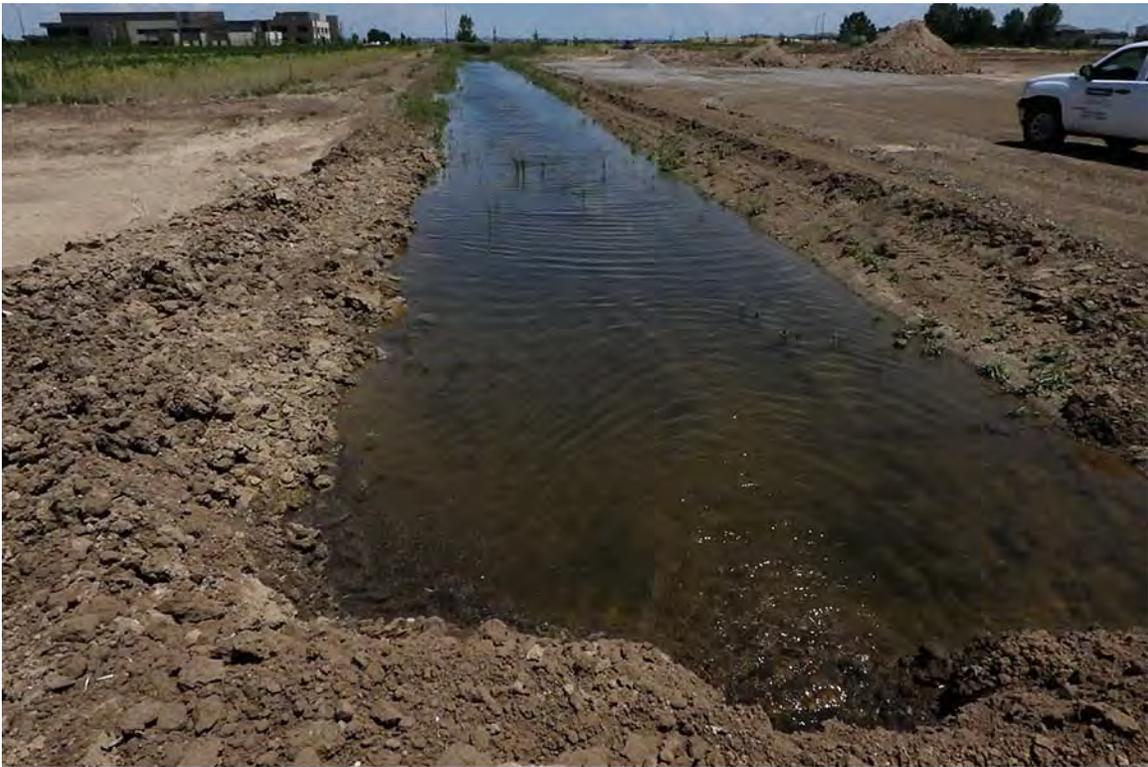
Photo 3. View of Re-constructed Ditch Segment Without Wetlands East of New Road Crossing. (View is looking east from new road crossing. Note bare dirt and complete lack of wetland vegetation in this segment.)

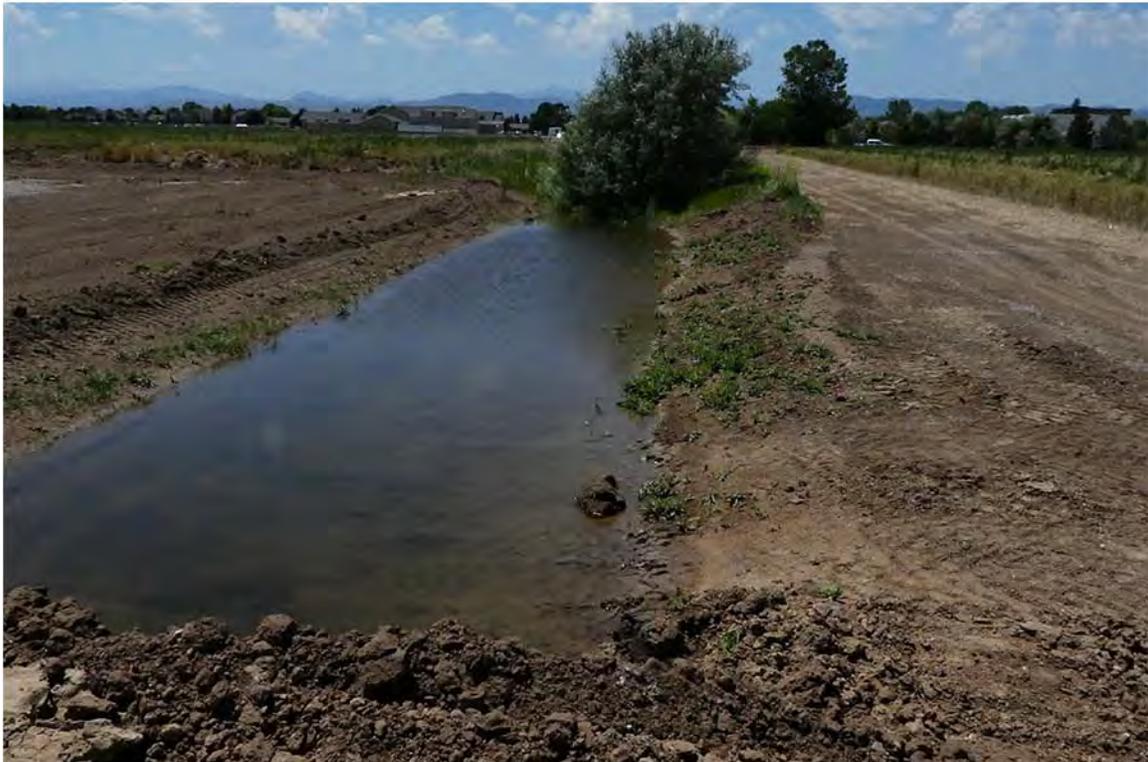
Photo 4. View of Re-constructed Ditch Segment Without Wetlands West of New Road Crossing. (View is looking west from new road crossing. Trees and shrubs in ditch in middle background are a Russian olive and a cluster of narrowleaf willows at the east end of the western segment ditch wetlands.)
