PAVEMENT DESIGN
PROPOSED BRITTANY PLACE DEVELOPMENT
TRILBY ROAD AND LEMAY AVENUE
FORT COLLINS, COLORADO

JOB NO. 1 557 84

JULY 2, 1984

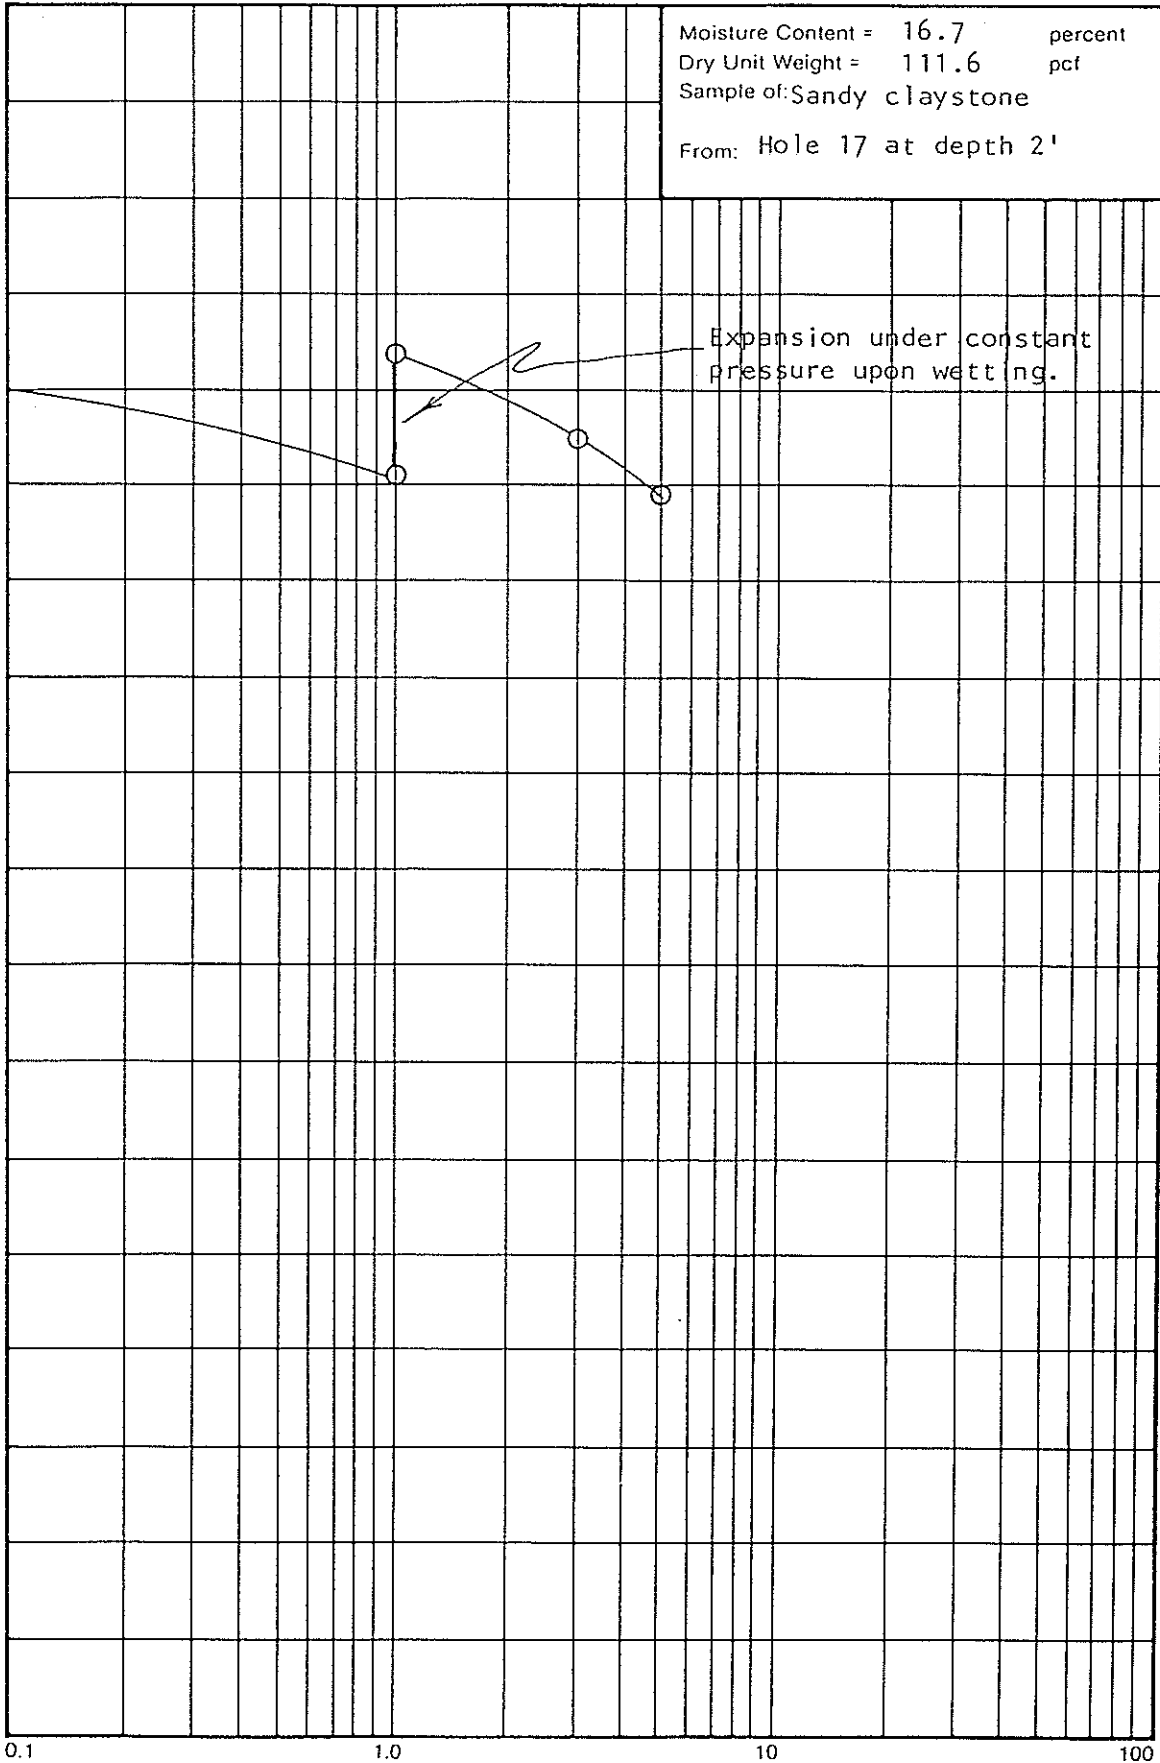
Moisture Content = 16.7 percent
Dry Unit Weight = 111.6 pcf
Sample of: Sandy claystone
From: Hole 17 at depth 2'

Expansion under constant pressure upon wetting.

Swell-consolidation tests performed on the overburden clays and claystone bedrock indicate they possess a low to moderate swell potential upon saturation and loading. The results of swell-consolidation tests are shown on Figs. 5 through 7. For pavement design, laboratory tests consisting of index properties and Hveem stabilometer tests were performed to evaluate the soil support characteristics of the subsurface soils. The test results indicate "R" values range from 8 to 13 for both the clay and claystone. Moisture-density relationships and Hveem stabilometer test results are shown on Figs. 8 through 15. The laboratory test results are summarized on Table I.

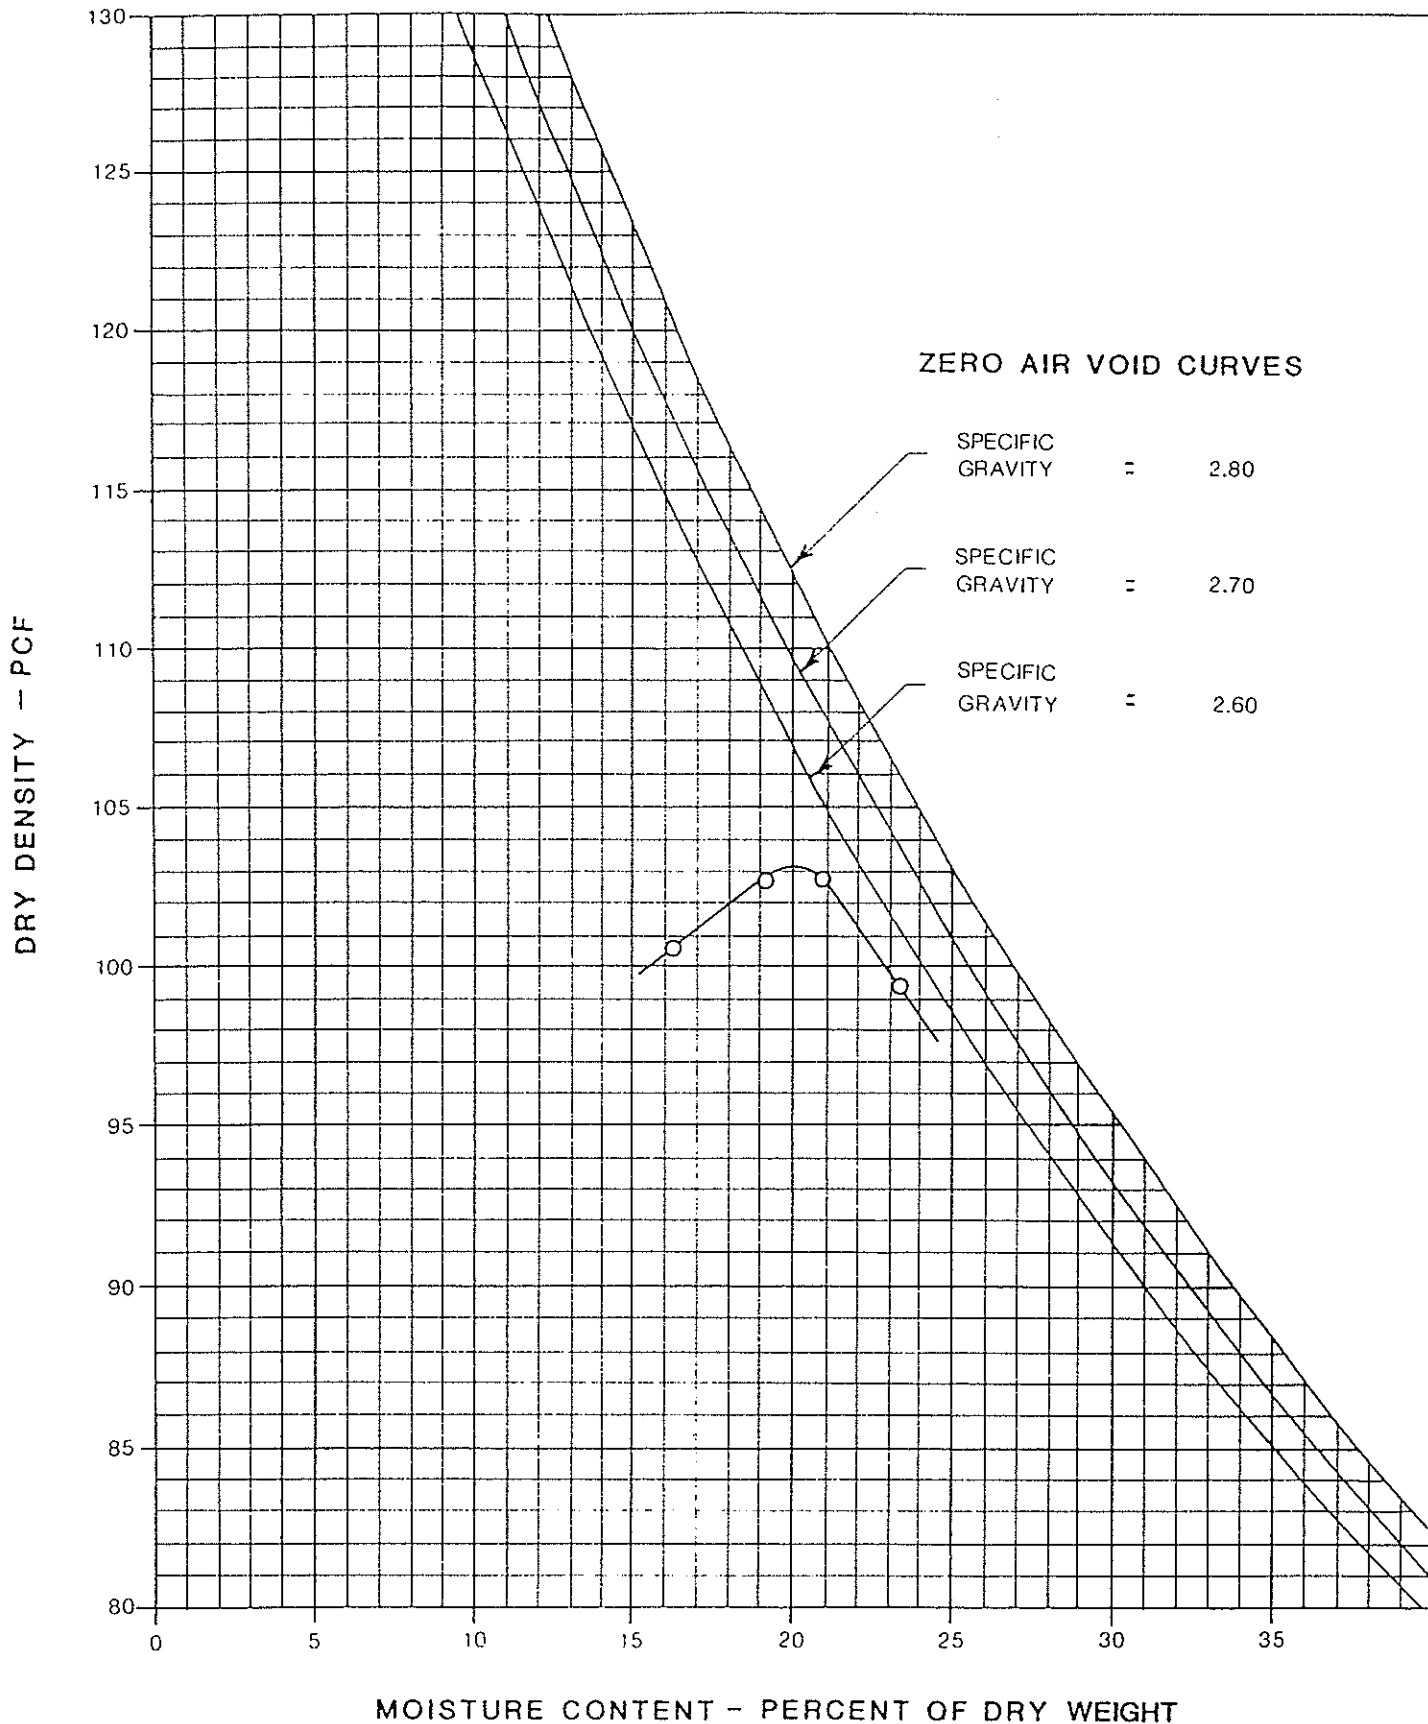
HOLE NO.	DEPTH NO.	SAMPLE NO.	MAXIMUM DRY DENSITY	OPTIMUM MOISTURE CONTENT	SOIL DESCRIPTION	COMPACTION TEST	
						CHEN AND ASSOCIATES, INC.	
3	0.5'	-	103.2 pcf	20.0%	Sandy clay	METHOD: ASTM-D-698-78 Method A	
						JOB NO.: 1 557 84	FIG. NO. 8
						DATE: May 1984	
					LL 53 PI 36 -200 89 %

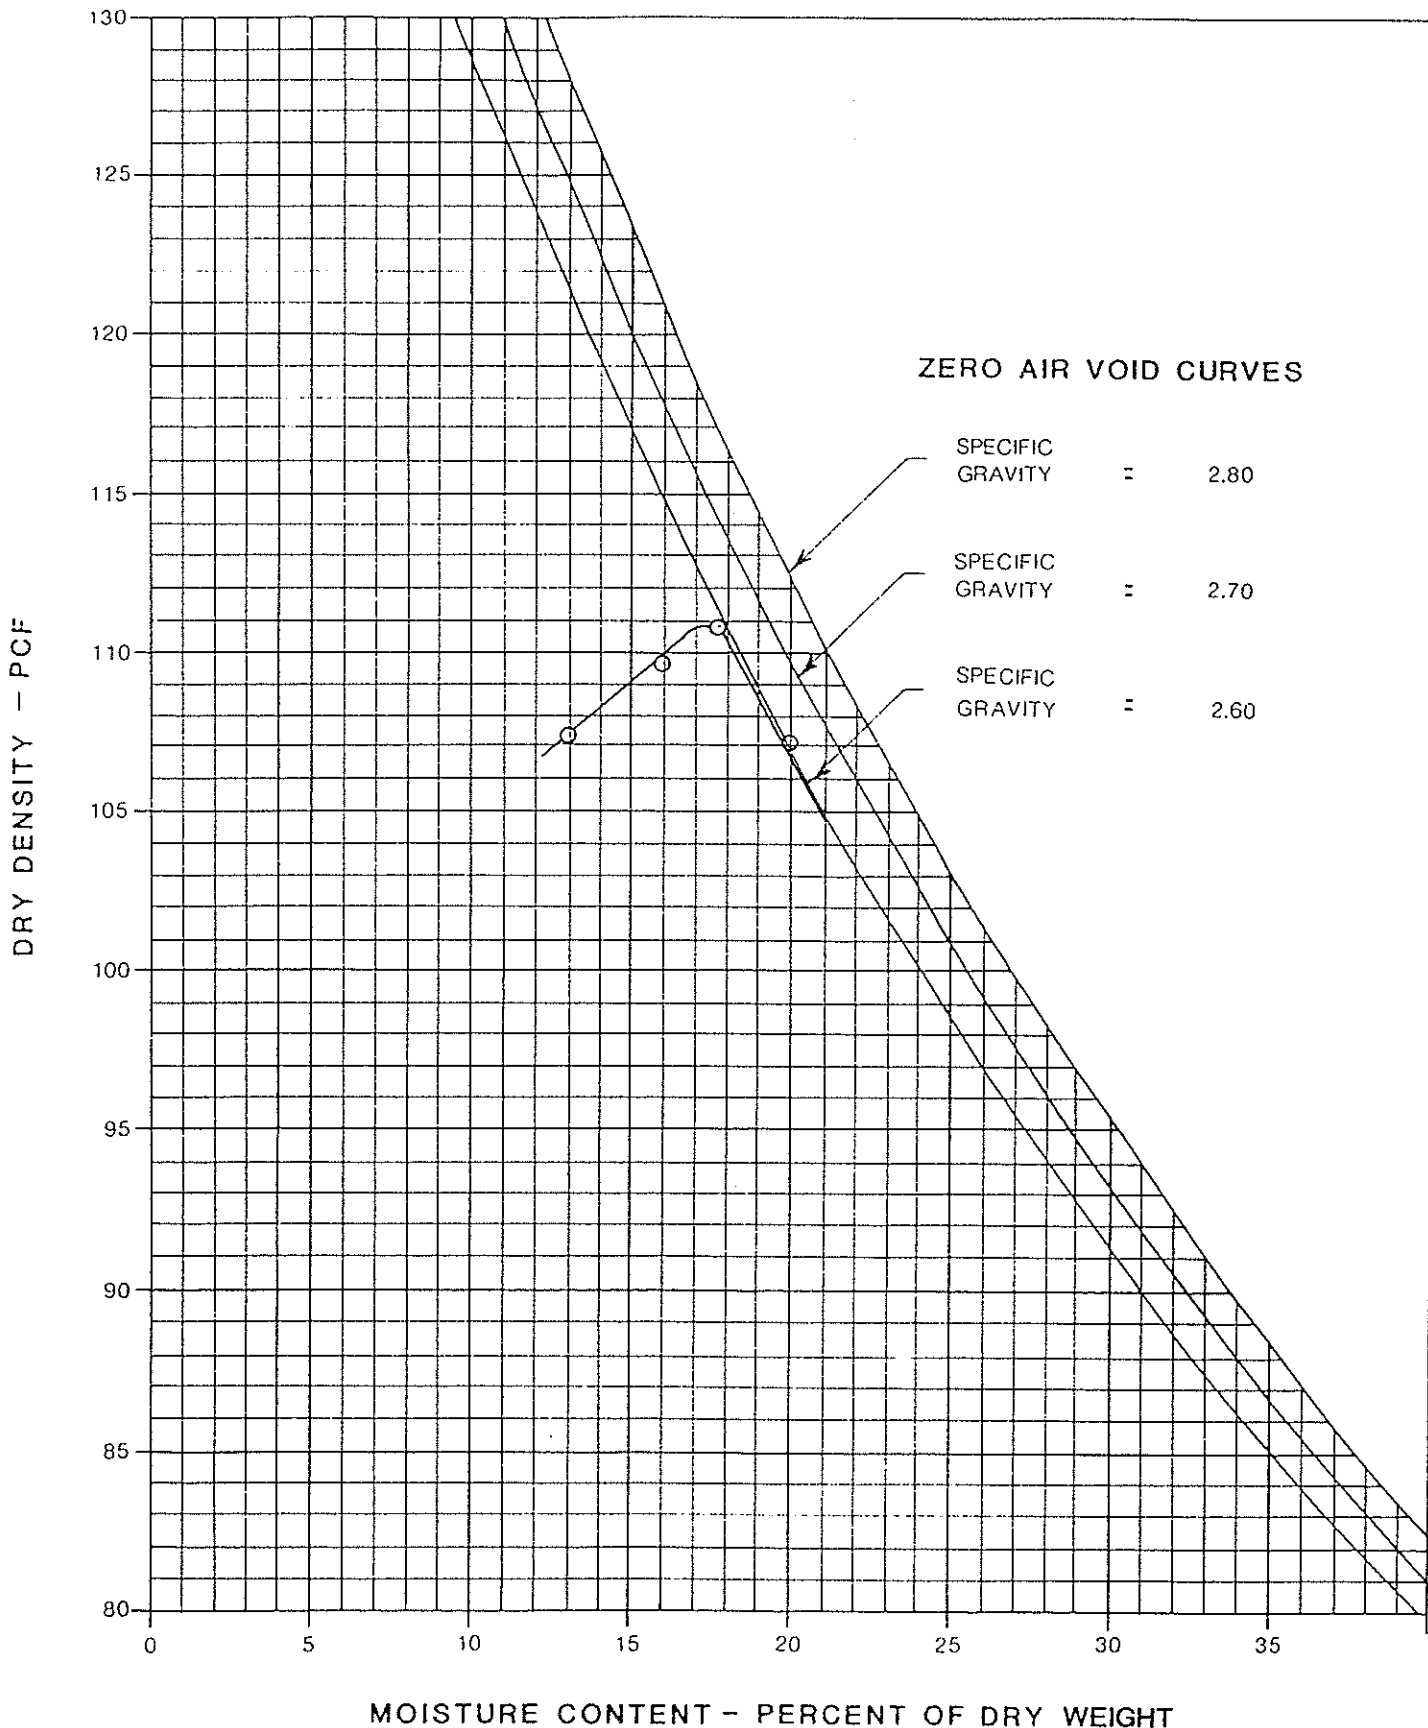
HOLE NO.	DEPTH NO.	SAMPLE NO.	MAXIMUM DRY DENSITY	OPTIMUM MOISTURE CONTENT	SOIL DESCRIPTION	COMPACTION TEST	
						CHEN AND ASSOCIATES, INC.	
15	1.5'		110.9 pcf	17.4 %	Claystone LL <u>51</u> PI <u>36</u> -200 <u>83</u> %	METHOD: ASTM-D-698-78 Method A	
						JOB NO.: 1 557 84	FIG. NO. 9
						DATE: May 1984

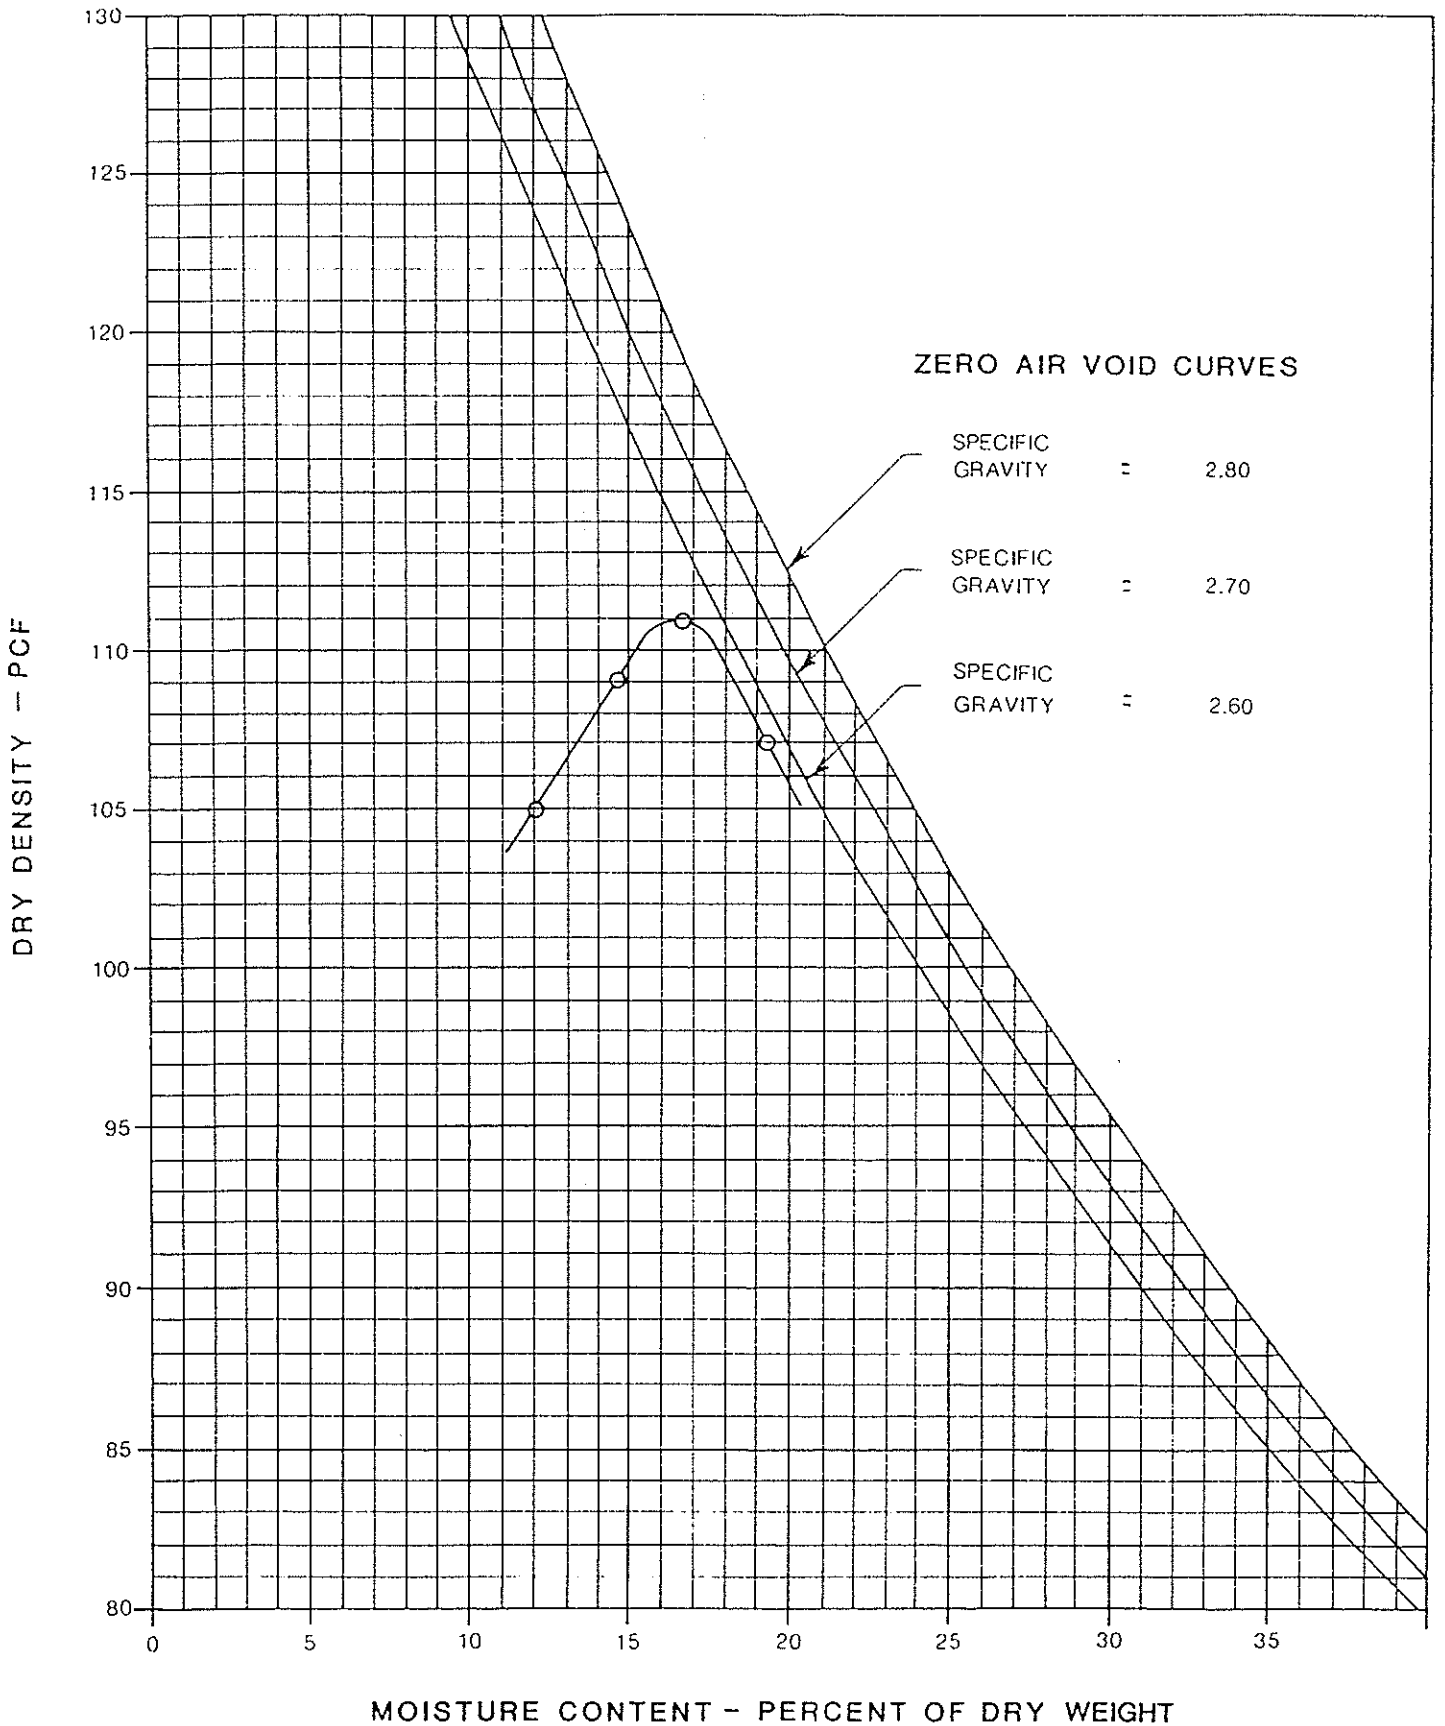
HOLE NO.	DEPTH NO.	SAMPLE NO.	MAXIMUM DRY DENSITY	OPTIMUM MOISTURE CONTENT	SOIL DESCRIPTION	COMPACTION TEST	
						CHEN AND ASSOCIATES, INC.	
24	0.5'-6'		110.9 pcf	16.4%	Sandy clay	METHOD: ASTM-D-698-78 Method A	
						JOB NO.: 1 557 84	FIG. NO. 10
						DATE: May 1984

LL 42 PI 28 -200 81 %

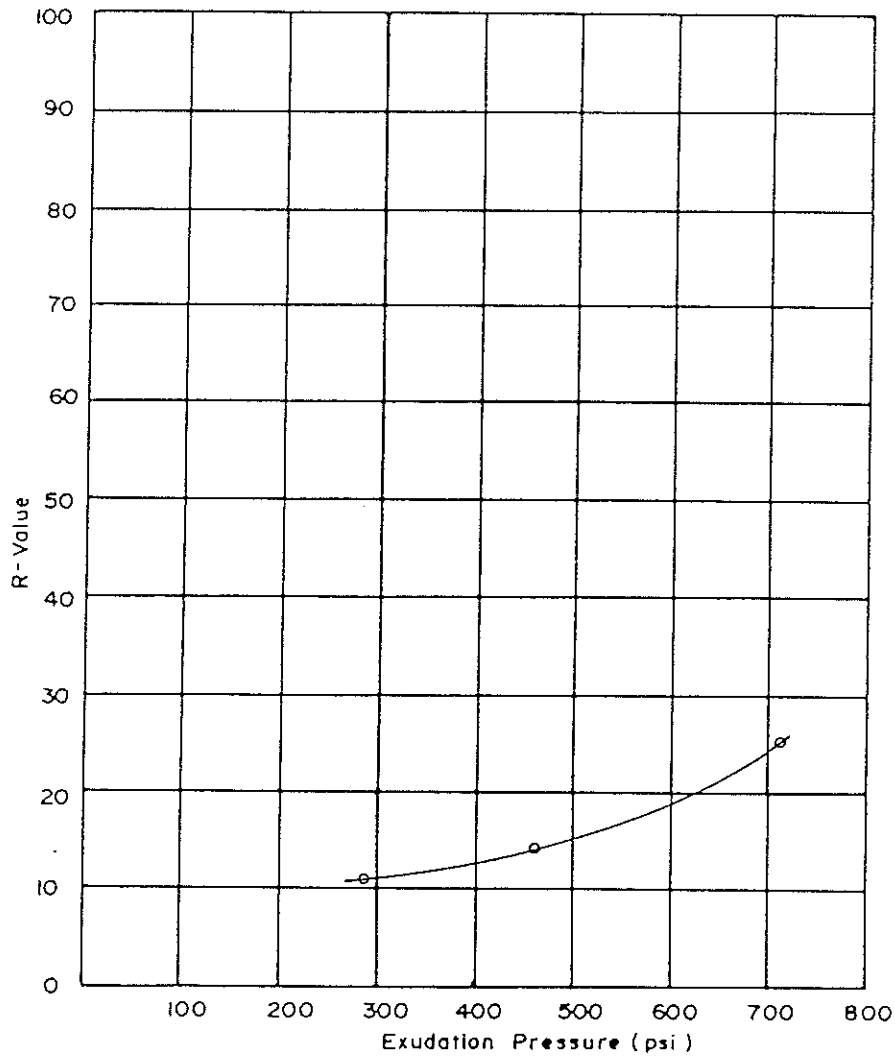
Test Specimen	1	2	3	4	R-Value (300 psi)
Moisture Content (%)	22.0	20.1	18.0		
Density (pcf)	102.2	107.3	109.9		
R-Value by Exudation Pressure	11.2	14.7	25.2		11

Soil Type Sandy clay

Location Hole 3, 0.5' to 6'

Gravel 0 % Sand 11 % Silt and Clay 89 %

Liquid Limit 53 % Plasticity Index 36 %

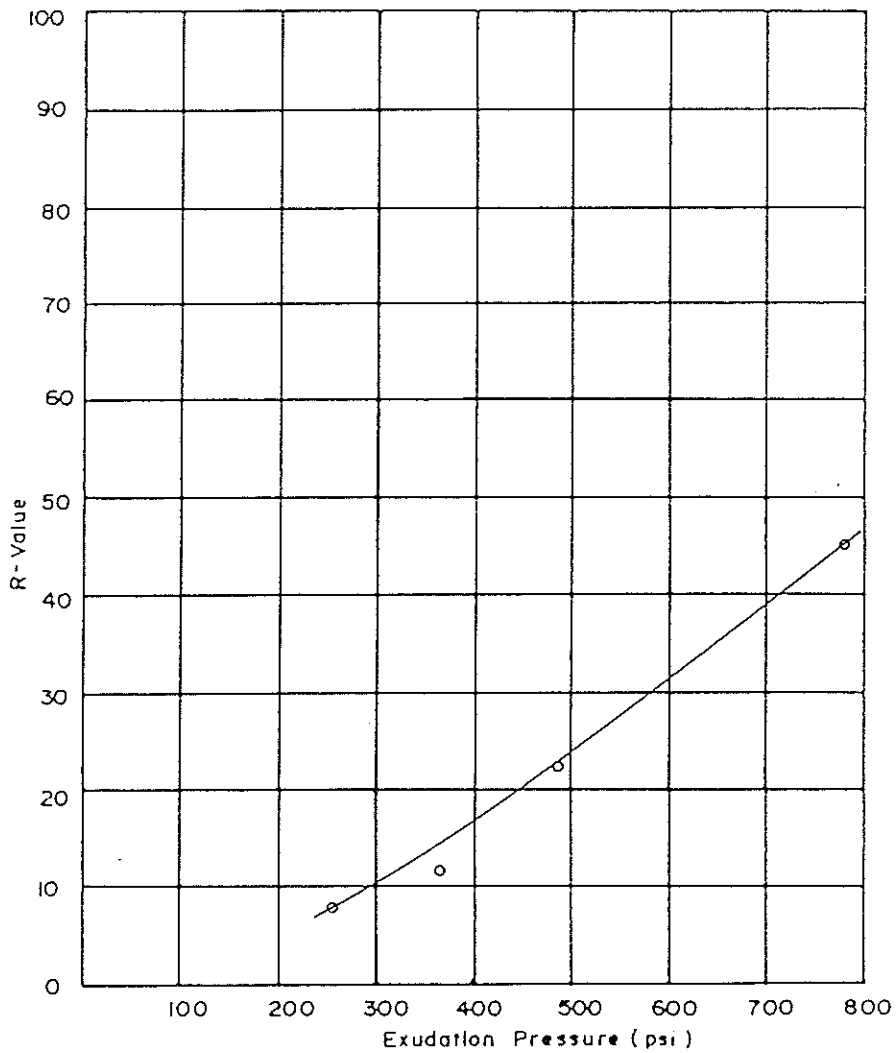
Test Specimen	1	2	3	4	R-Value (300 psi)
Moisture Content (%)	20.7	19.4	17.4	15.3	
Density (pcf)	105.1	107.1	112.8	119.2	
R-Value by Exudation Pressure	8.8	11.8	23.0	45.8	8

Soil Type Sandy clay

Location Hole 10, 0.5' to 10'

Liquid Limit 43 % Plasticity Index 28 %

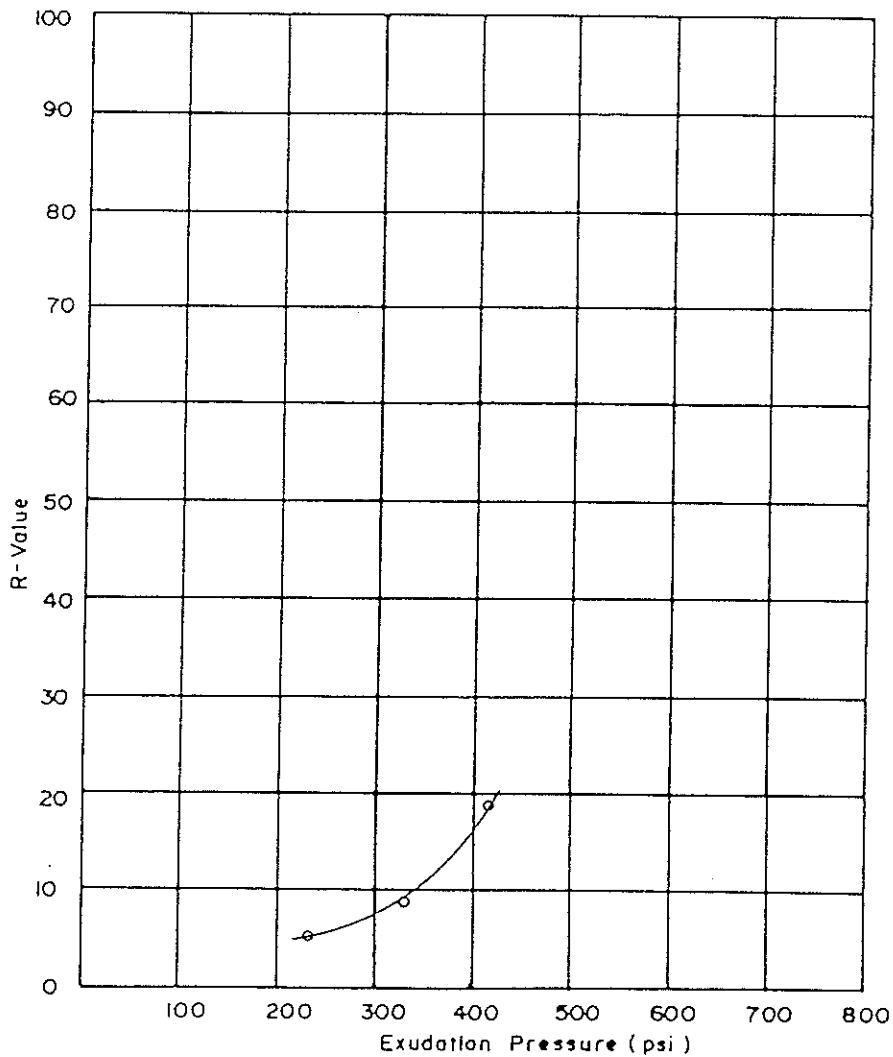
Test Specimen	1	2	3	4	R-Value (300 psi)
Moisture Content (%)	19.8	18.3	17.4		
Density (pcf)	109.1	112.2	114.1		
R-Value by Exudation Pressure	5.8	9.4	19.3		8

Soil Type Claystone

Location Hole 15, 1.5' to 8'

Liquid Limit 51 % Plasticity Index 36 %

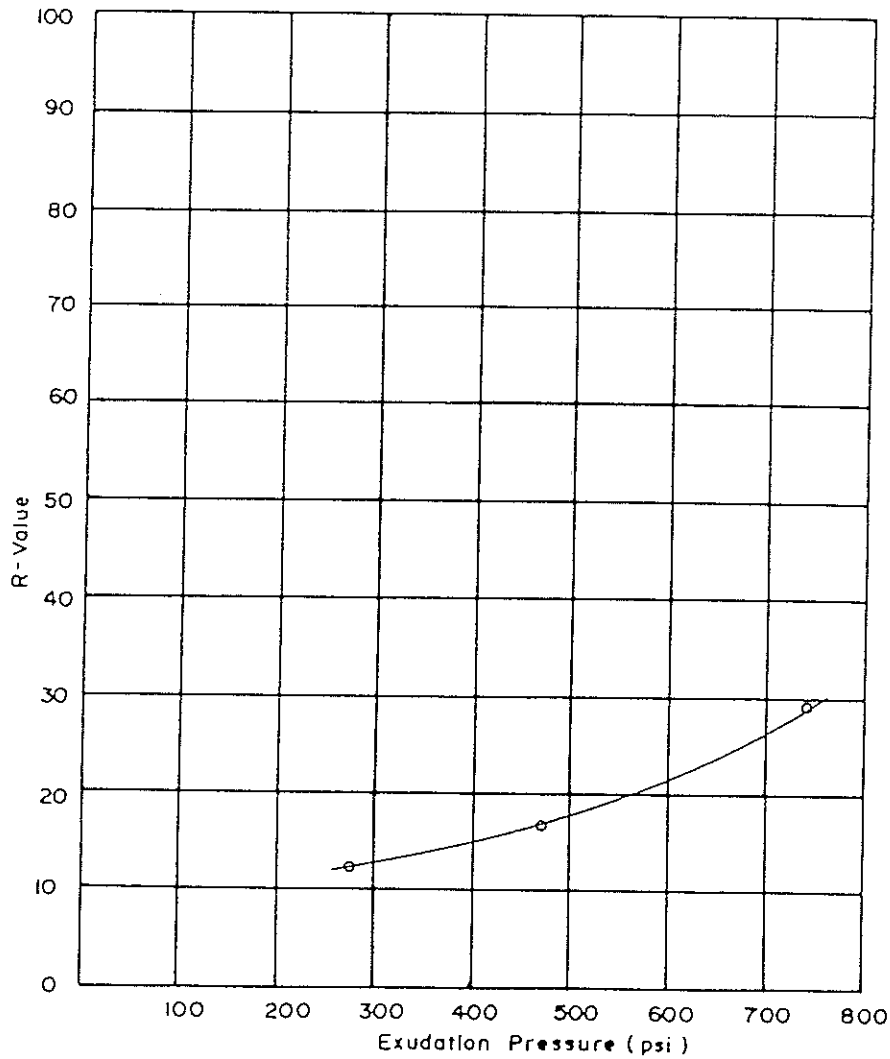
Test Specimen	1	2	3	4	R-Value (300 psi)
Moisture Content (%)	18.6	17.0	15.1		
Density (pcf)	111.8	114.2	118.0		
R-Value by Exudation Pressure	12.6	17.5	29.3		13

Soil Type Sandy clay

Location Hole 24, 0.5' to 6.0'

Liquid Limit 42 % Plasticity Index 28 %

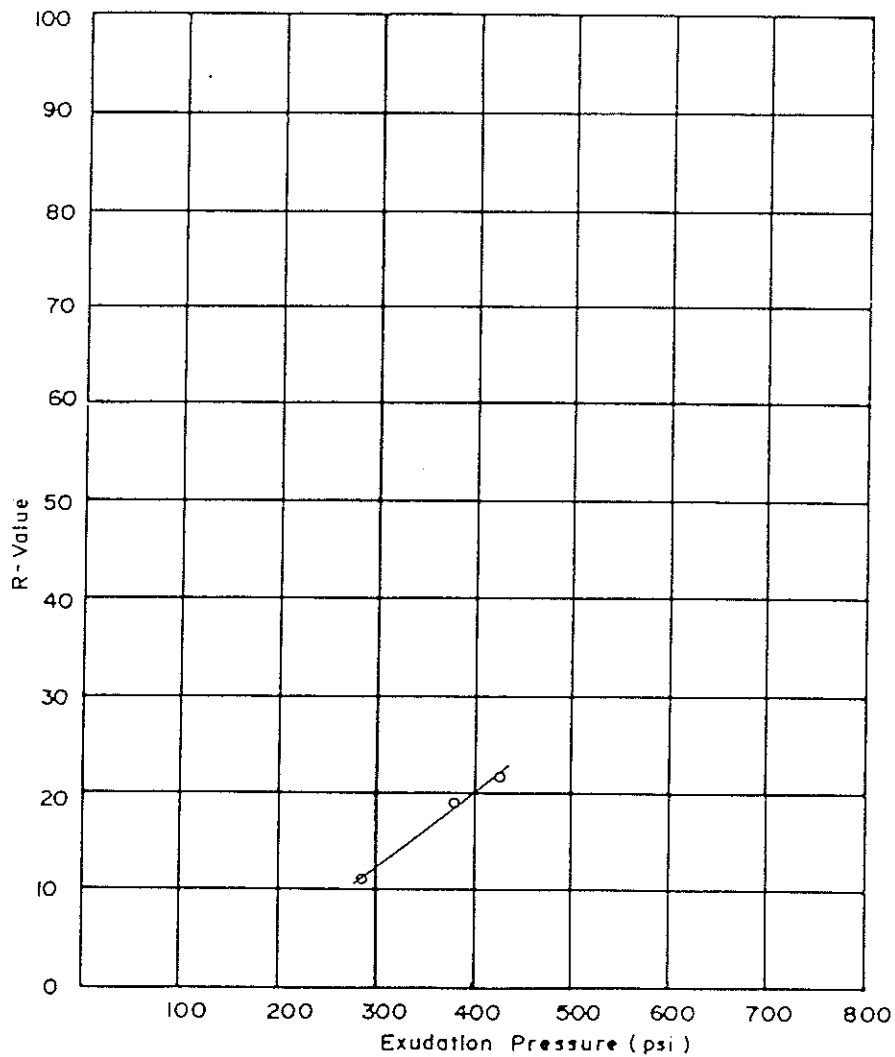
Test Specimen	1	2	3	4	R-Value (300psi)
Moisture Content (%)	16.8	15.8	15.5		
Density (pcf)	114.5	115.1	116.3		
R-Value by Exudation Pressure	11.9	19.6	21.2		12

Soil Type Weathered claystone

Location Hole 26, 0.5' to 6.0'

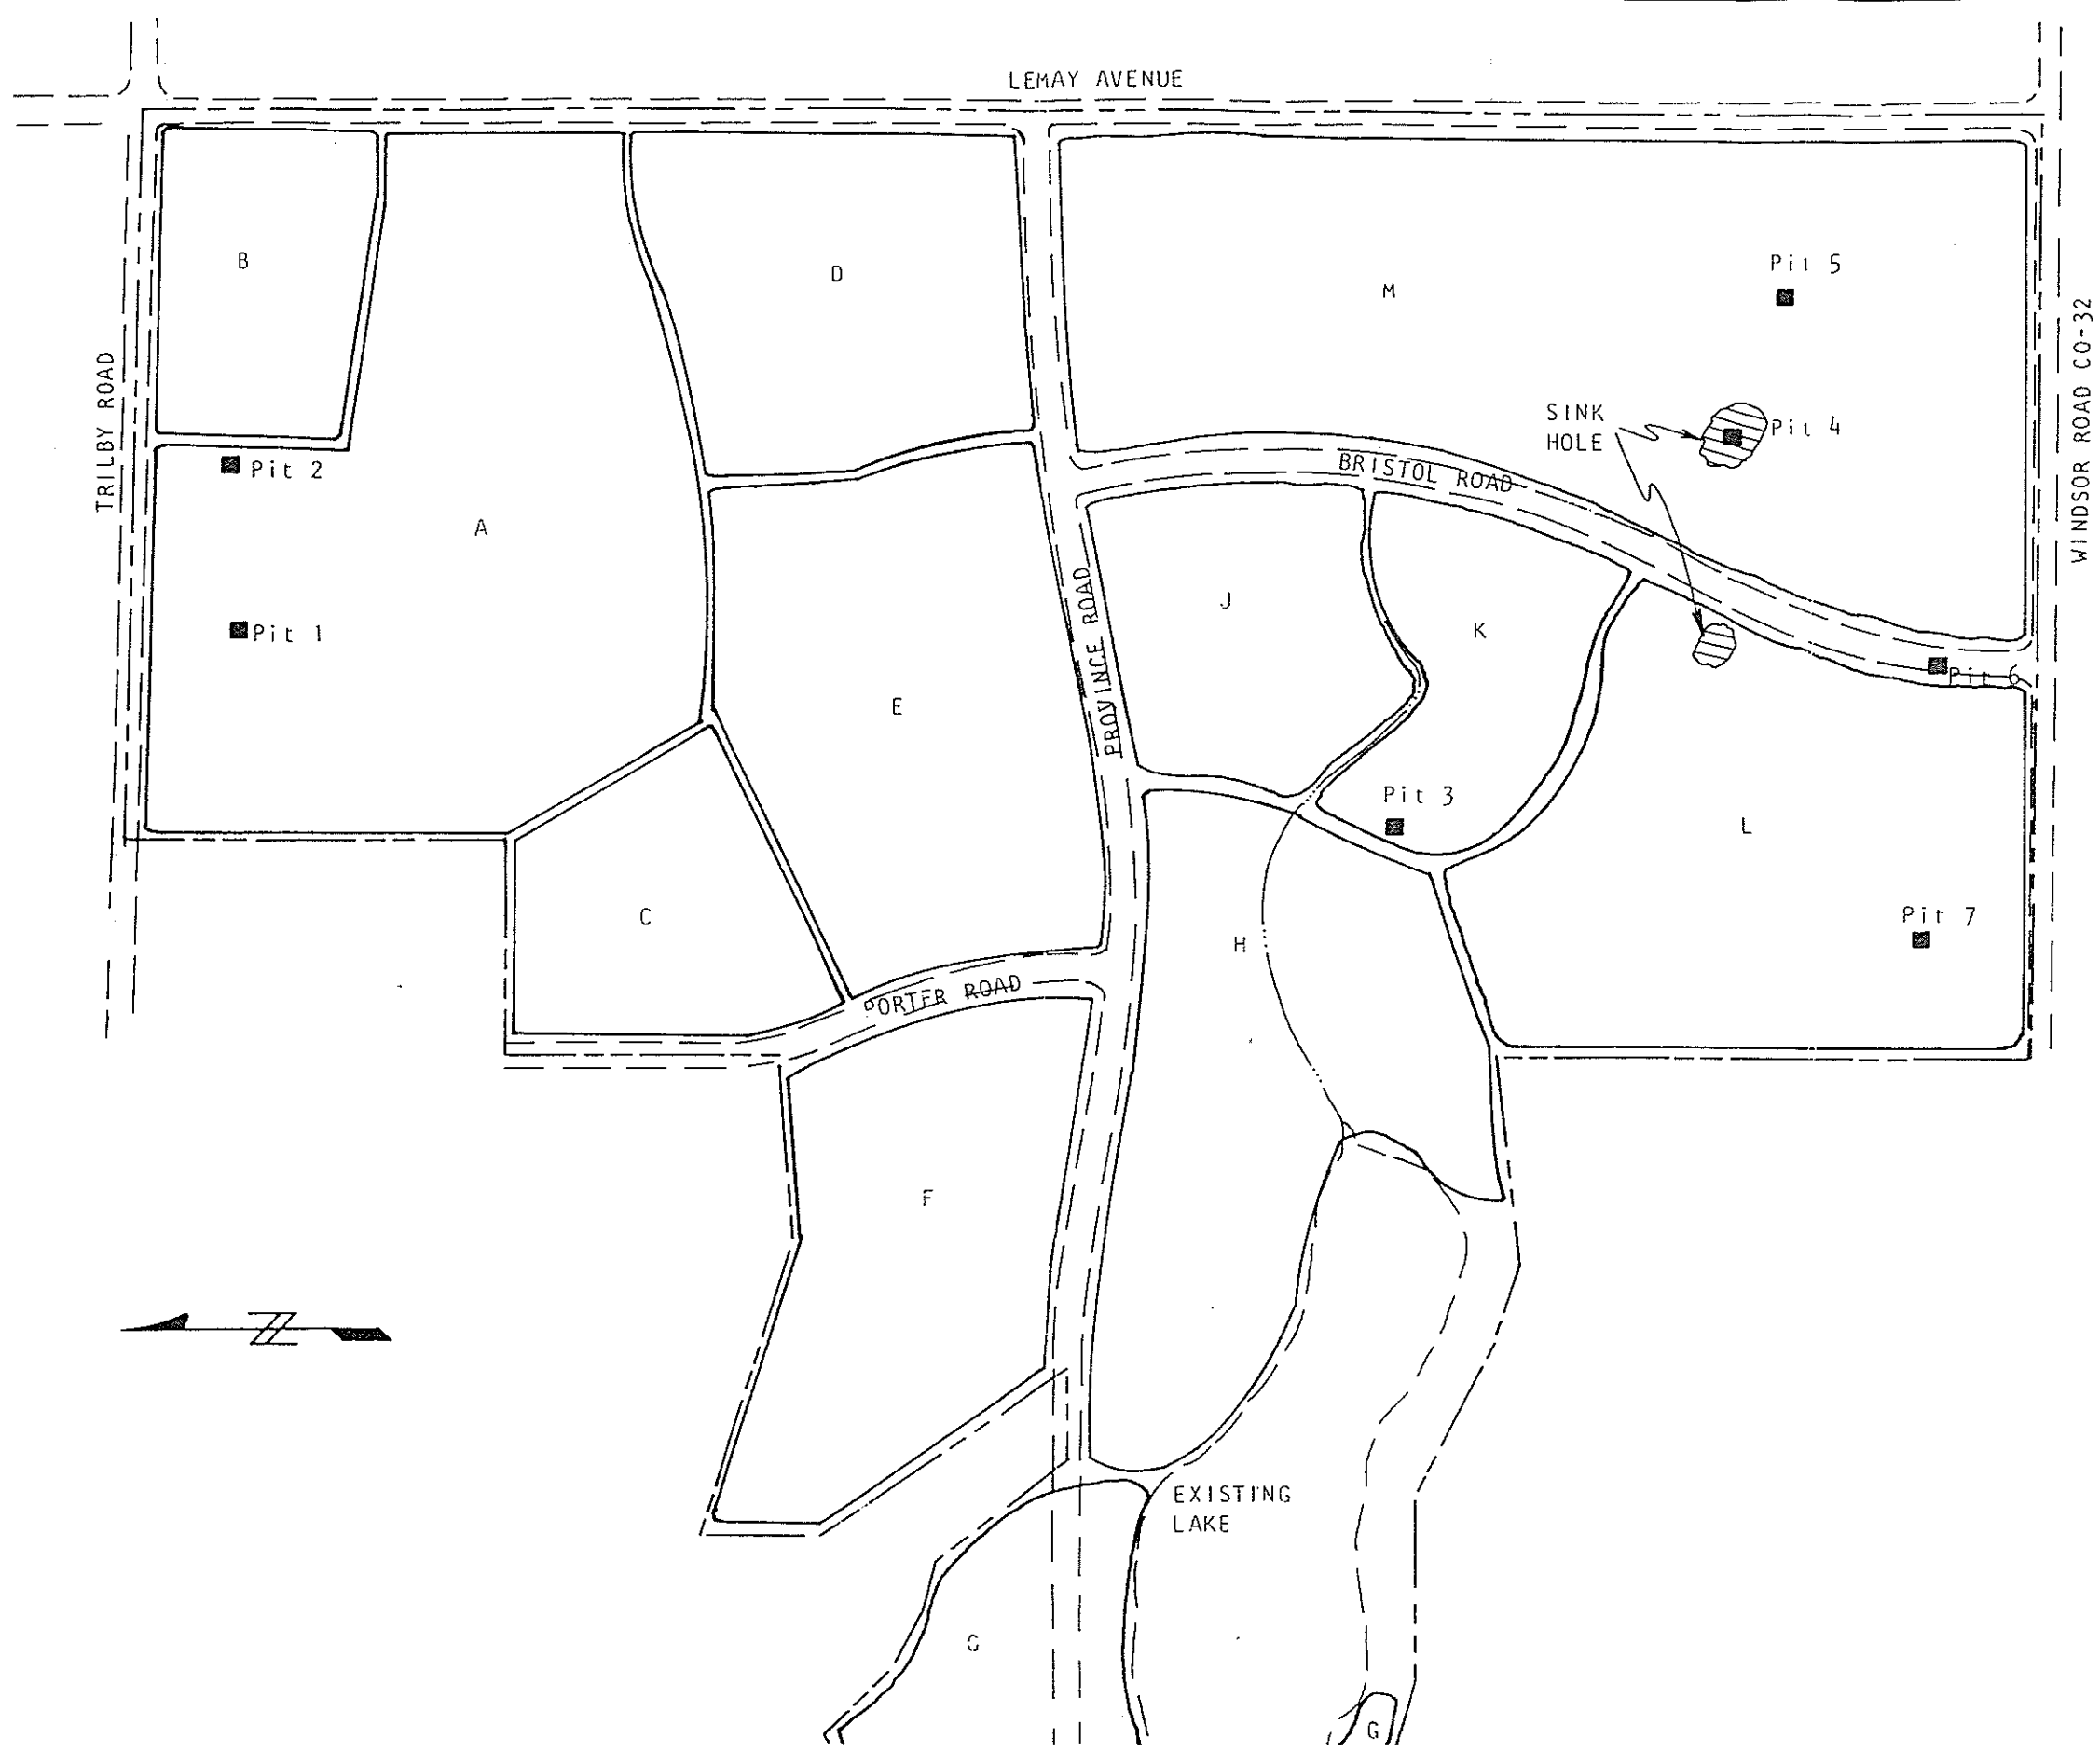
Approximate Scale: 1"=300'

The subsurface investigation at the site was performed by excavating 7 Test Pits at the approximate locations shown on Fig. 1. The logs of exploratory pits are shown on Fig. 2. The subsurface conditions are highly erratic due to the large area investigated. With the exception of Test Pit 4, the subsurface condition consists of zero to a thin veneer of topsoil overlying 1 to 19.5 feet of stiff to very stiff, sandy clay overlying medium to very hard, claystone bedrock. One and a half feet of weathered claystone bedrock was also encountered in Test Pit 1. Bedrock was not encountered in Test Pit 7 to the maximum excavated depth, 20 feet. Occasional thin cemented

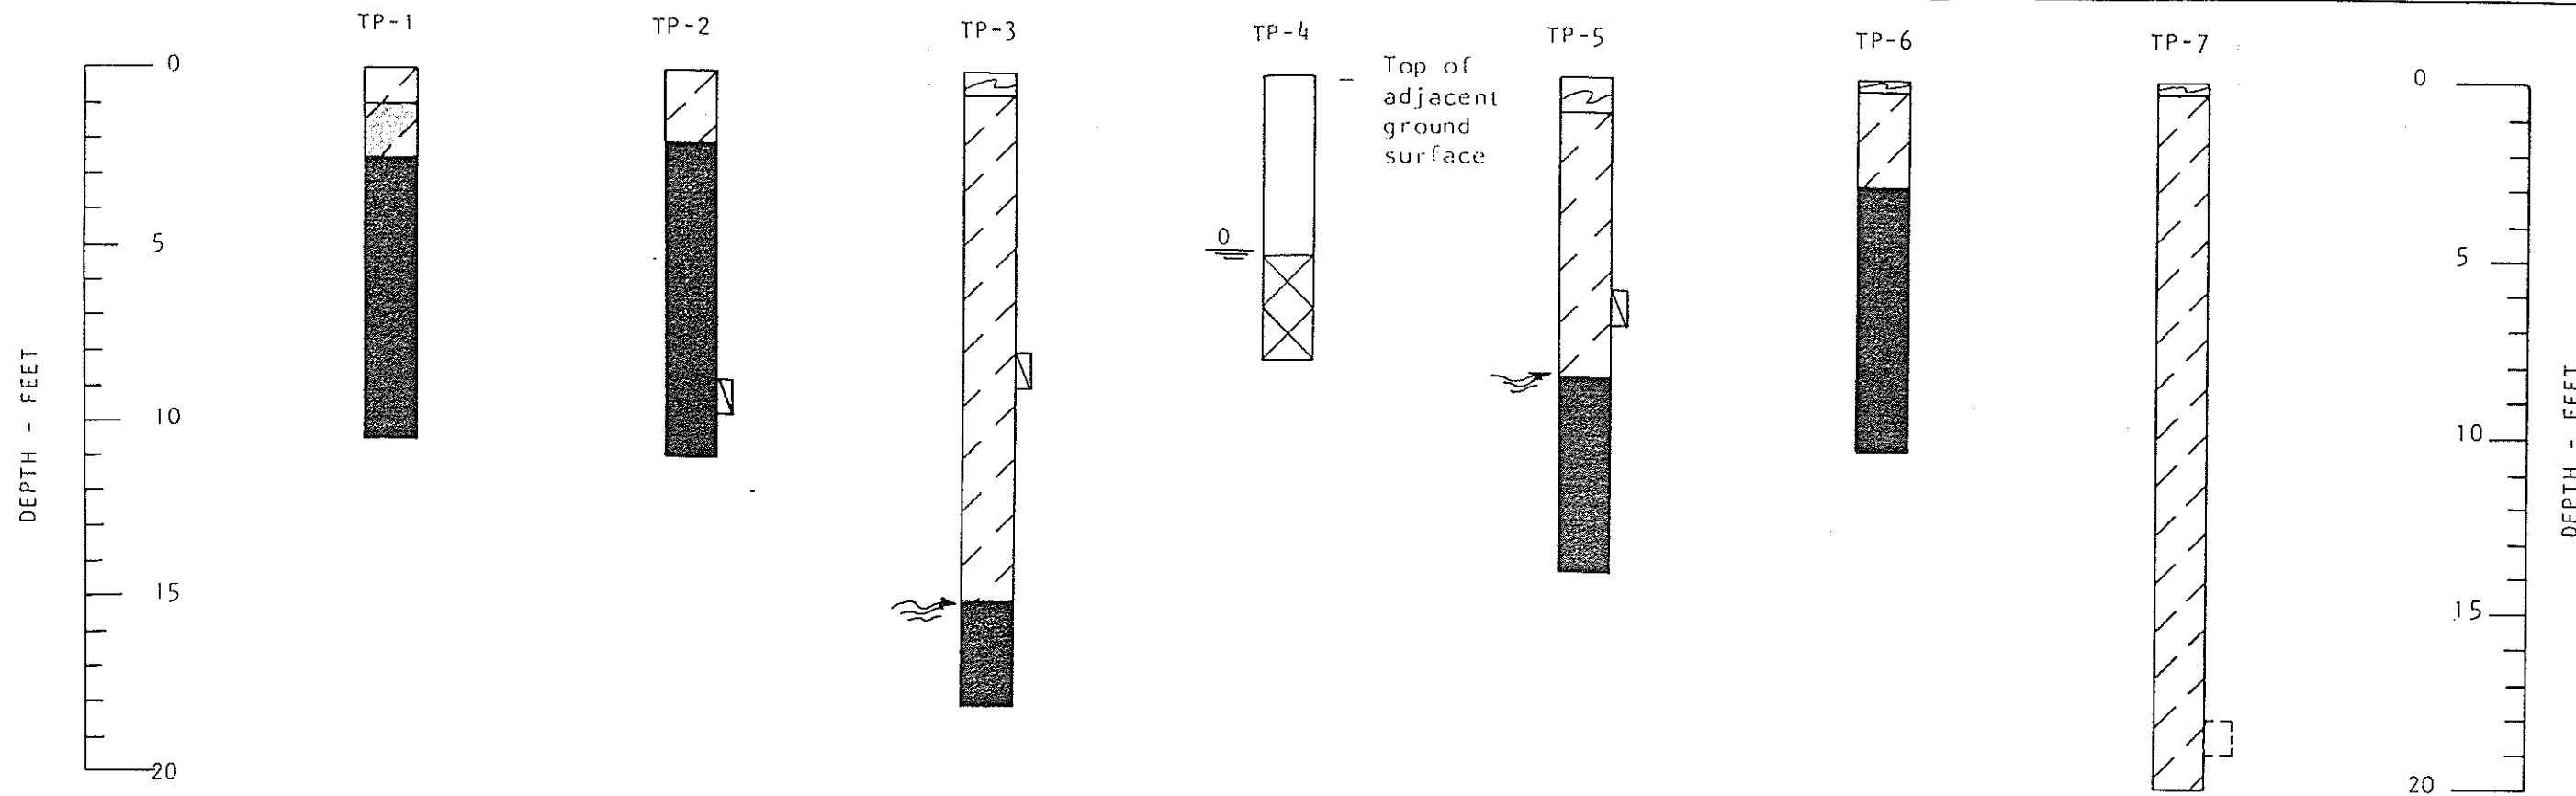
Clay (CL), sandy to very sandy, medium stiff to very stiff, slightly moist to very moist, brown.
-

Claystone bedrock, sandy, occasional thin cemented sandstone lenses, medium to very hard, moist, brown and black.
-

1. Test pits were excavated with Bantam 266 backhoe.
2. Locations of test holes were measured approximately by pacing from features shown on the site plan provided.
3. Elevations of test holes were not measured and logs of test holes are drawn to depth.
4. Water level readings shown on the logs were made at the time and under conditions indicated. Fluctuations in the water level may occur with time.
